**POND ASSESSMENT AND ENHANCEMENT OPPORTUNITIES
THE MEADOWS AT MELODY RANCH
TETON COUNTY, WYOMING**

September 3, 2015

POND ASSESSMENT AND ENHANCEMENT PLAN
THE MEADOWS AT MELODY RANCH
TETON COUNTY, WYOMING

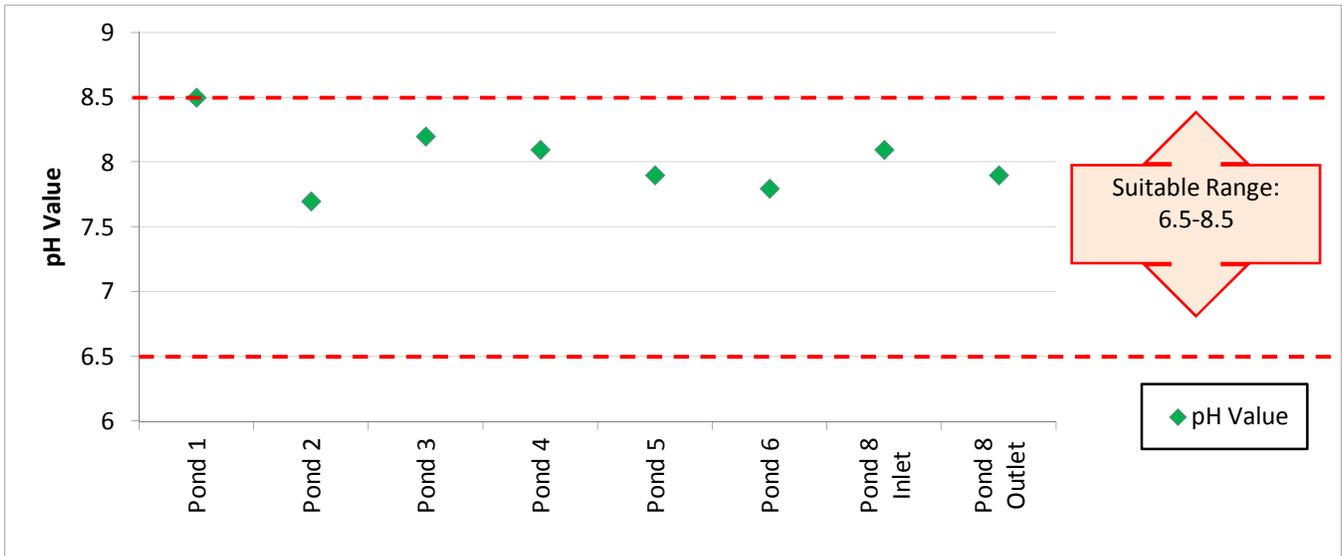
Figure 1. pH values for pond water quality samples, The Meadows at Melody Ranch HOA property.

All pH values were within the suitable range of 6.5 – 8.5, although the pH in Pond 1 was at the upper limit of the range (Figure 1). A factor that contributes to explaining the high pH value in Pond 1 is that algae concentrations were high and the water sample was collected mid-day during the peak of photosynthetic activity.

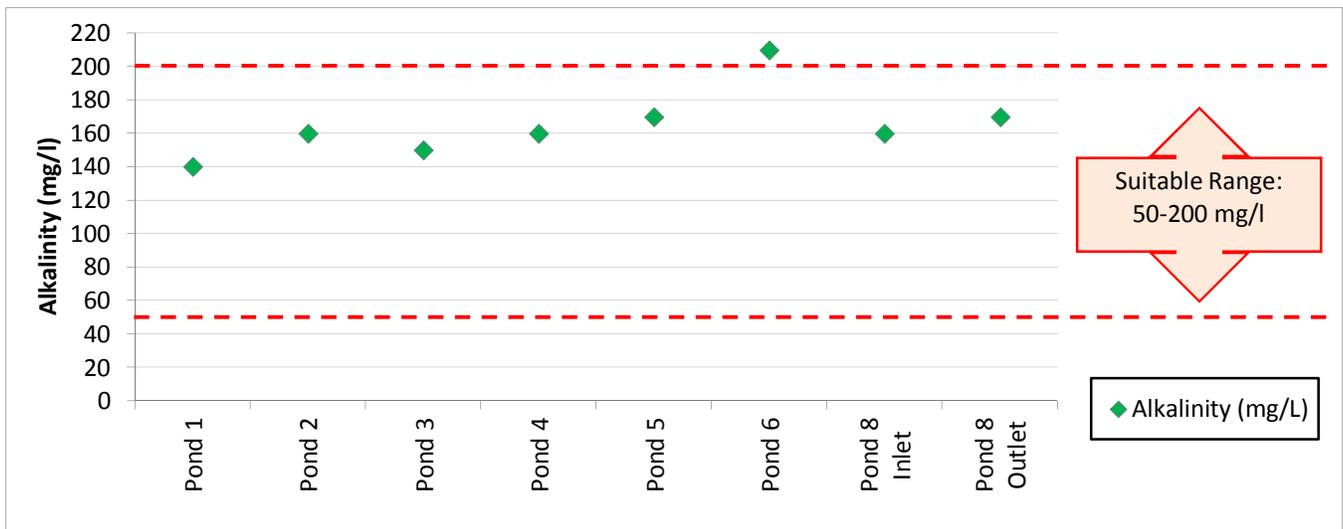
Figure 2. Alkalinity values for pond water quality samples, The Meadows at Melody Ranch HOA property.

The total alkalinity levels in all samples were within the suitable range of 50-200 mg/L, except for the Pond 6 sample, which was 210 mg/L (Figure 2). Levels greater than 120 mg/L are ideal in order to sustain a healthy system and promote microbial consumption of organics in the water column. When alkalinity levels are below 100 mg/L, microbial production is inhibited and pH is susceptible to fluctuation. Several conditions can then influence pH, including the presence of highly productive aquatic plant communities, large die-offs in the plant community, and the presence of decaying material. Given that the alkalinity measurements were 140 mg/L or greater, the current alkalinity of the pond is not likely a serious matter.

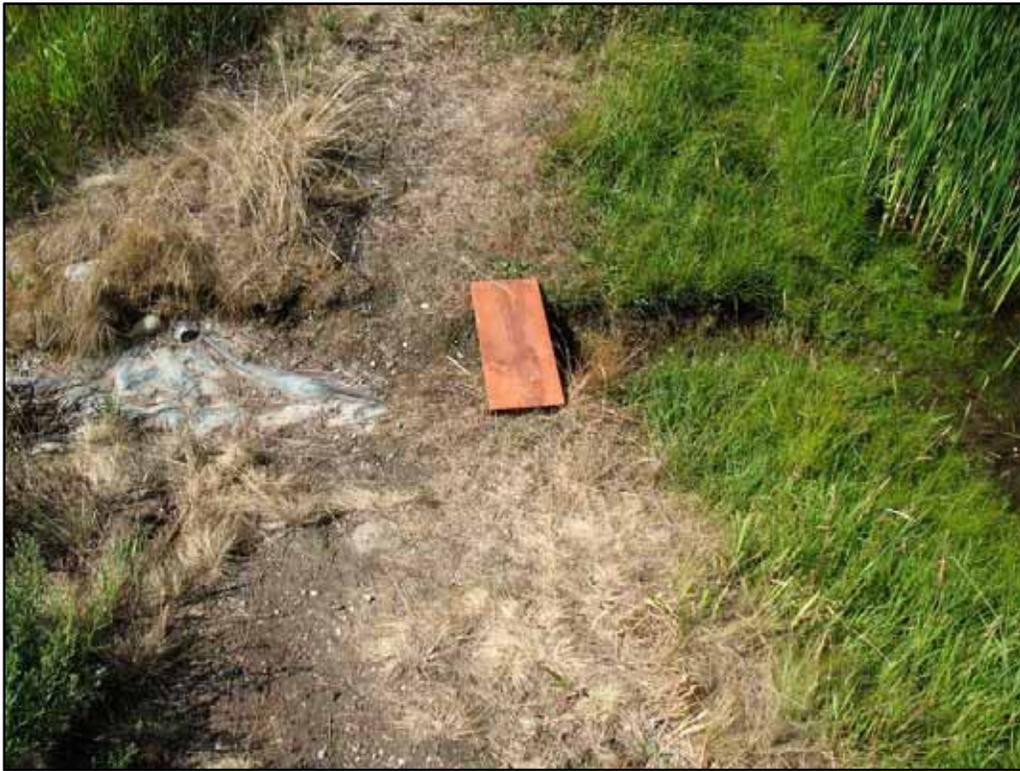
Photograph P5. Photograph depicting the outlet of Pond 1 and a portion of exposed liner.

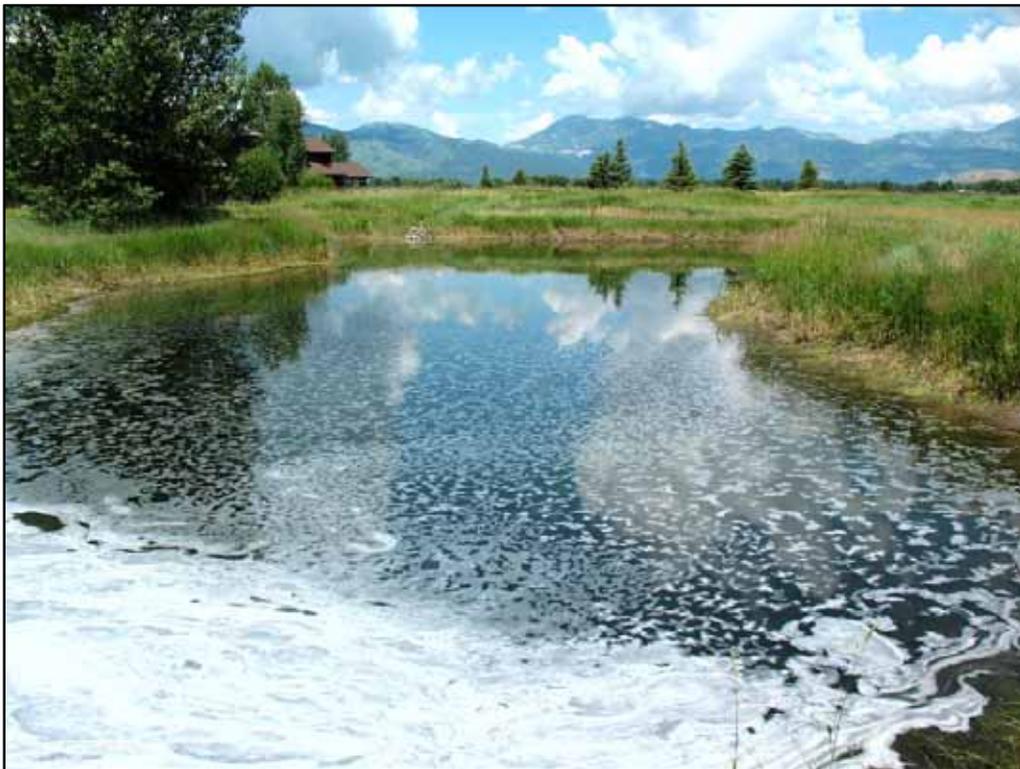
A layer of white foam was observed in the southern portion of the pond during the July visit (Appendix 2-Photo P16). The foam was apparently the result of a recent enzyme treatment performed by Mountain Town Management. Photos of Pond 3 from the field investigations are presented in Appendix 2 (Photos P13-P18).

Photograph P16. Photograph depicting Pond 3 after treatment and agitation of Bio-Zyme, looking northeast (July 2015).

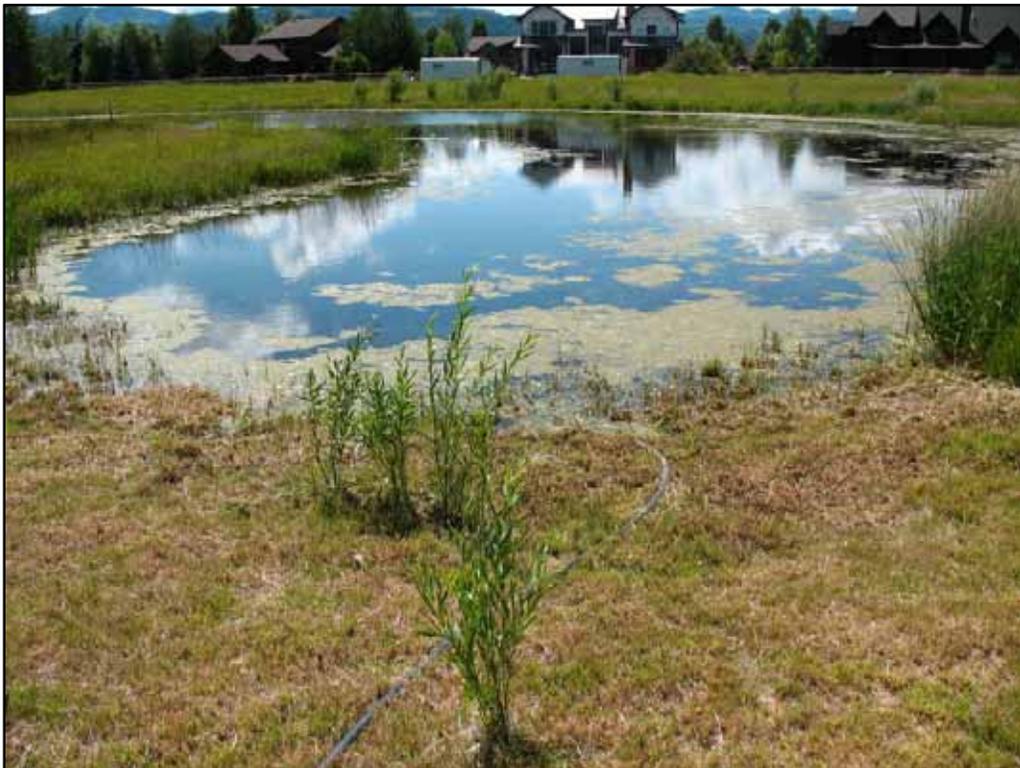
Photograph P28. Photograph depicting the northeastern portion of Pond 5 and an area where vegetation was mowed to the edge of water, looking west (July 2015).

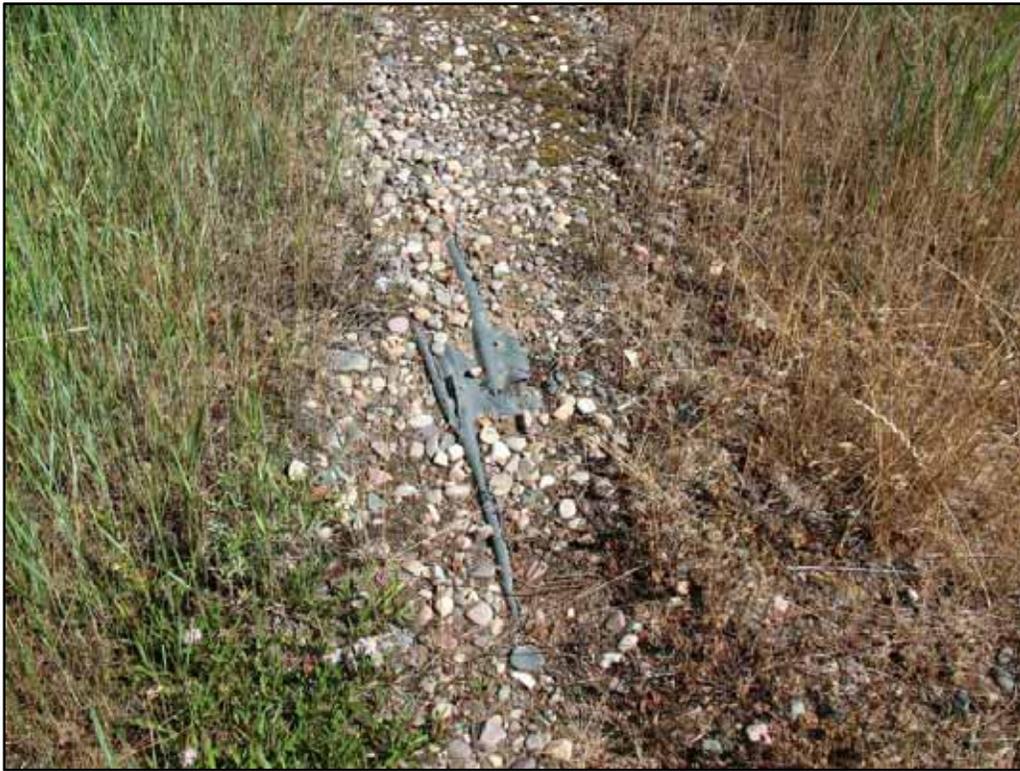
Photograph P35. Photograph depicting a portion of exposed pond liner at Pond 6 (July 2015).

Increasing pond depths would represent a significant effort, but would dramatically improve pond conditions and would provide an opportunity to repair leaking pond liners and address areas where pond liners are exposed. The effort would require excavation of material currently covering pond liners, removal of existing liners (which may or may not be salvageable), excavation of additional material to achieve desired water feature depth (of approximately 10-12 feet), installation of suitable pond liner with appropriate alluvium cover, and reclamation of construction access routes and disturbed areas. Biota is available to assist the Melody Ranch HOA in obtaining construction cost estimates for this type of work from qualified contractors, but the cost of these pursuits might warrant exploration of other recommended management strategies and infrastructure improvements first. Implementation of other recommended system improvements prior to pond deepening would not represent a waste; improved flow regimes and beneficial microbe treatments could continue after pond deepening, aeration systems could be re-installed and re-used after pond deepening, and lined delivery ditches could remain intact through the pond deepening process.

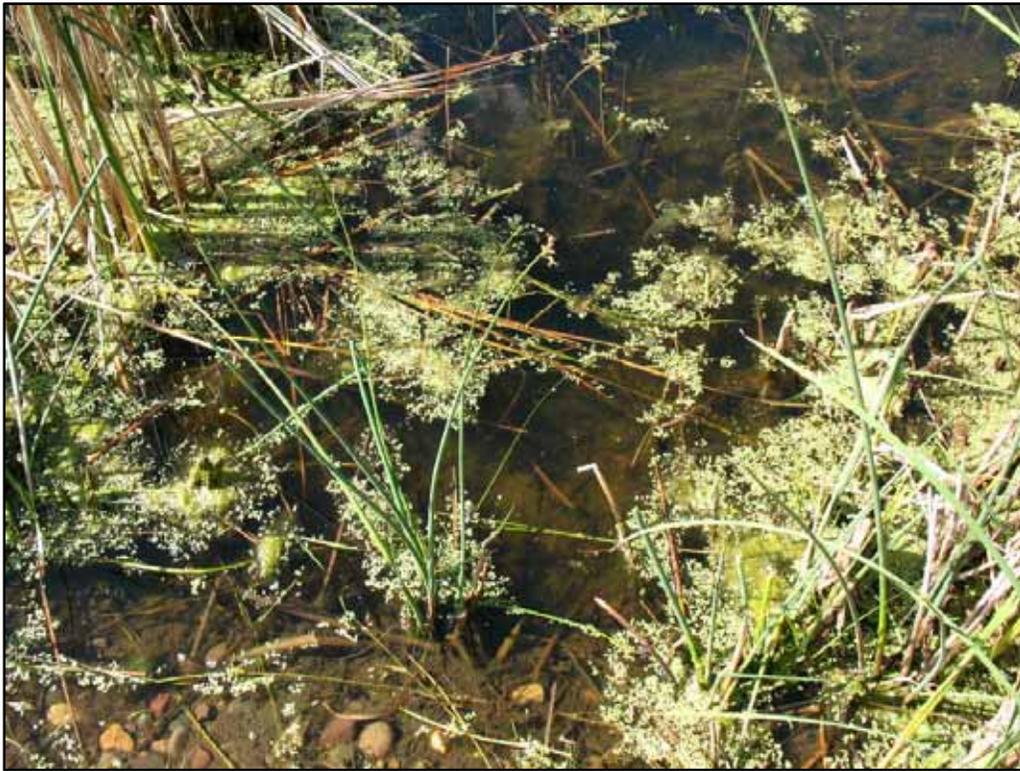
Photograph P41. Photograph depicting emergent and floating aquatic plants and filamentous algae in the northern portion of Pond 7 (July 2015).

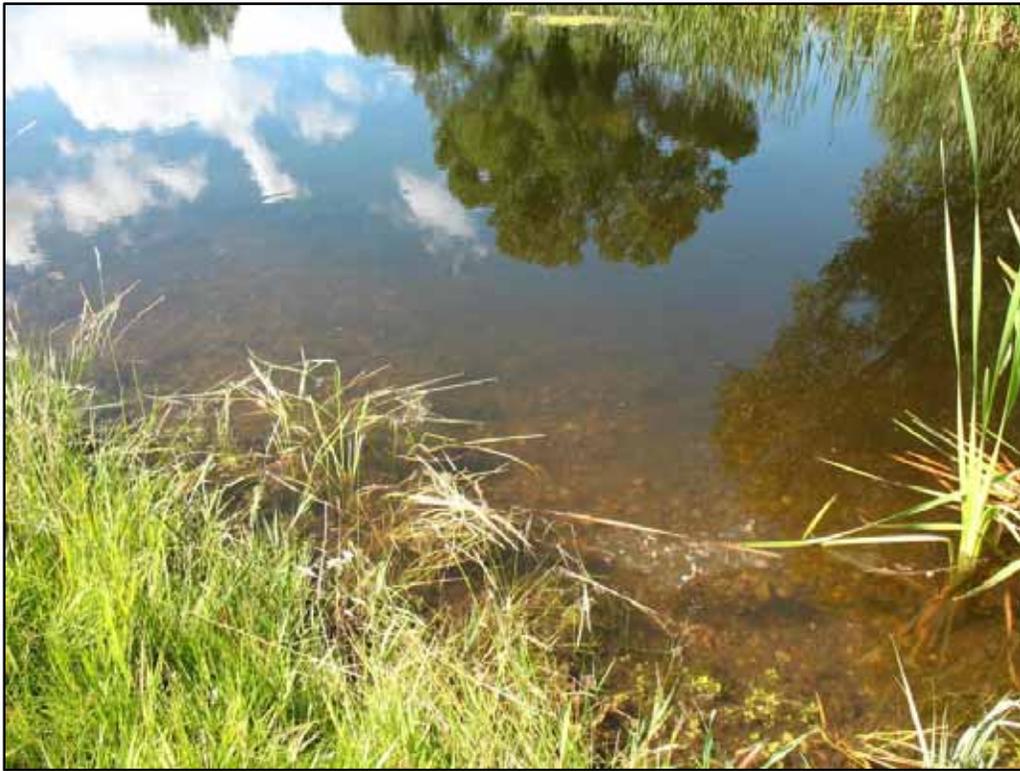
Photograph P47. Photograph depicting water clarity in Pond 8 in early summer (July 2015).
